Installing split-type replacement rubber bushings

2290010, 2290011 - 944 front control arm front bushing
2290010, 2290011 - 964/933 front control arm rear bushing
2290005, 2290026 - 911/912/930 trailing arm bushing
2290021, 2290013 - 996/997/986/987/RS60/981, and 991 front control arm inner bushing

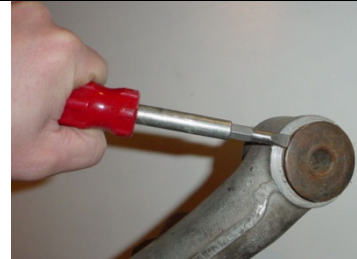
1 – Remove the rubber bushings.

Secure the control arm in a bench vise.

Heat the center metal spacers with a propane torch until hot. The center spacers can then be pried off with a screwdriver.

944/964/993 - Rubber is bonded in place. It takes more heat, more prying, and cutting with razor knife. Some rubber will remain.

Metal out casings will remain.

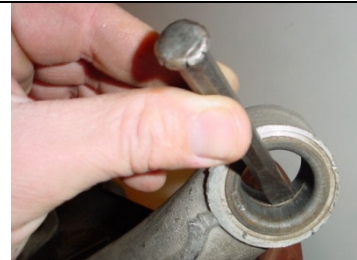
2 – Remove bushing outer metal casings.

Secure the control arm in a bench vise. The casing halves meet in the center of the bore. Using caution not to damage the soft aluminum of the control arm, position a chisel in the union between halves and drive them out from the bore. Sometimes it is difficult to get the casing half to move, some tips:

If they still won't come out, thread a hacksaw blade through the casing half and cut a slit part way through the casing. Careful not to cut the control arm, it is not necessary to cut all the way through the casing. The tension will be partly relieved. Once the slit is cut, return to the chisel technique.
